NASA CR - 135,403

**EVALUATION OF
FLAWED COMPOSITE STRUCTURAL COMPONENTS
UNDER
STATIC AND CYCLIC LOADING**

**Boeing Aerospace Company
A Division of The Boeing Company
Seattle, Washington**

**NASA Lewis Research Center
Contract NAS3-19709
Gordon T. Smith, Project Engineer**

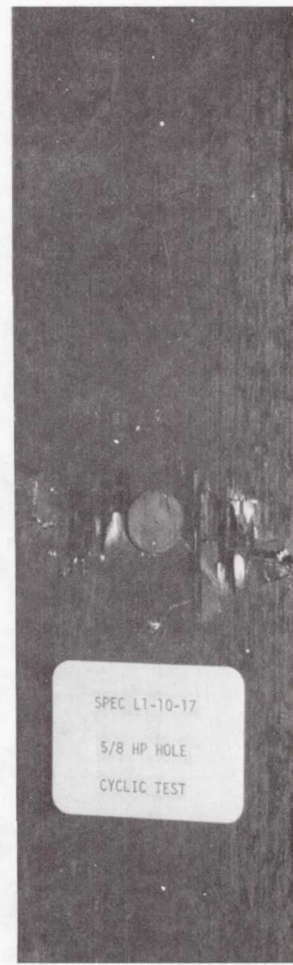
Figure E-15. Tension-Compression Fatigue ($R = -1.0$) Laminate L1 Test Specimens Containing a Full- and a Half-Penetration Hole

- 7,300 cycles
- Fatigue Failure

- 22,800 cycles
- Fatigue failure

- 3,100 cycles
- Fatigue failure
